# TRUNK HINGE REPAIR

by Scott McGilvray

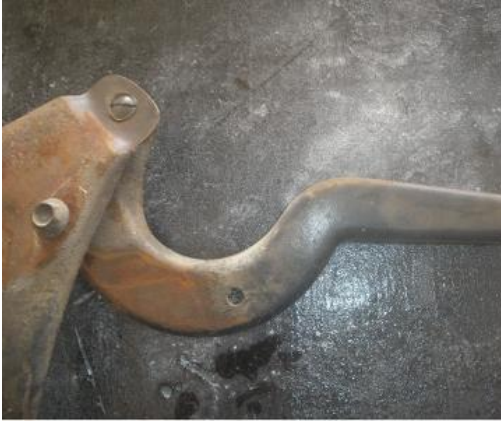
The first picture shows the rivet going through the bracket. I have drawn a line on the rivet to show its orientation to the arm. See picture two and see that the rivet moves with the arm

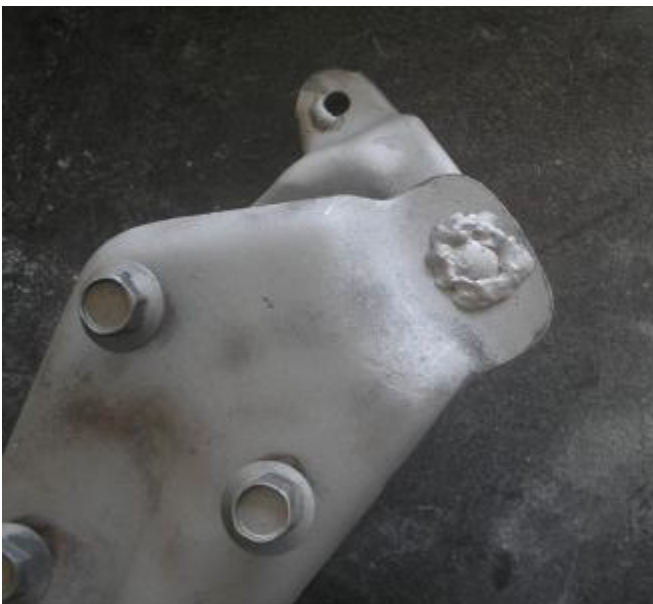
**Picture #3**

the arm and elongated the hole. This repair is actually more important than the rivet since it has to do with spring length and thus tension. Often because of low spring tension trunks will not stay fully open. It is important to operate the arm in case it is stuck to the shoulder part of the rivet. Penetrant will make the parts move well over the other but it is not possible to get any long lasting lubricant to the working area. Remember, you will be painting the hinge sooner or later.
